## Introduction

- Current study is based on panels commissioned as part of a BIPV for 8 years, and currently stacked on site as spares. This study could reveal annual degradation in panels that are stacked on site, exposed to ambient conditions, but not in operation.
- These panels were also studied for the impact of soiling on operating cell-temperatures and other defects.
- Thirty-three 9-year-old monocrystalline Photovoltaic (PV) panels were inspected for degradations and simultaneous PV performance using thermal imager and I-V curve tracers respectively.
- Picture (A) shows the setup for degradation inspection and I-V curve measurement of PV panels. The setup is located at Centre for Sustainable Technologies, Indian Institute of Science campus, Bangalore.

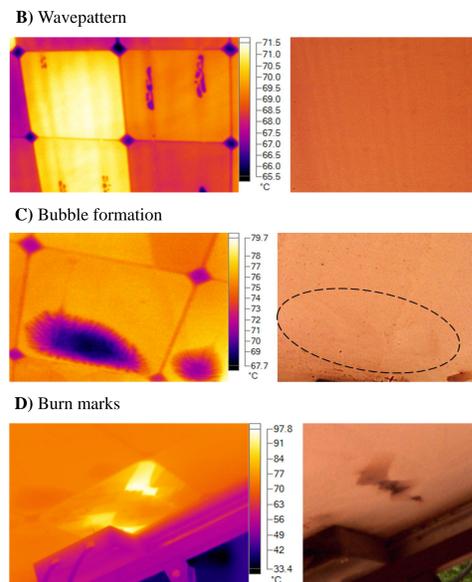
- Typical defects observed through thermal imagery were hot spots, hot cells, cell cracks, wavelattern, bubble formation, burn marks. Thermal images of few typical defects and their corresponding visible spectrum image are shown below (B - D)

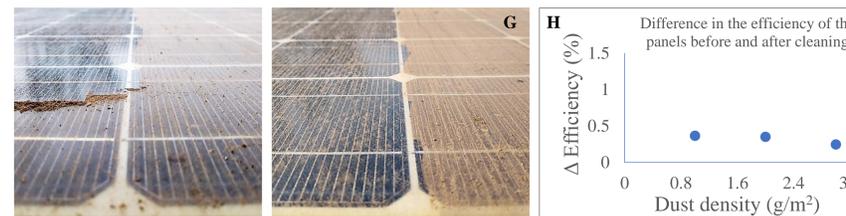
- The dust measurement were made row wise (panel has 72 cells, 12 rows and 6 columns). The row numbering starts from the junction box side, which is on the right hand side during our measurements. Picture (G) below shows the dust collection in progress.

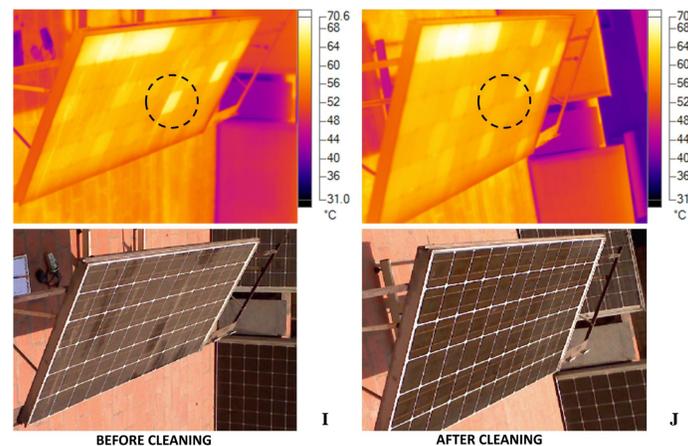
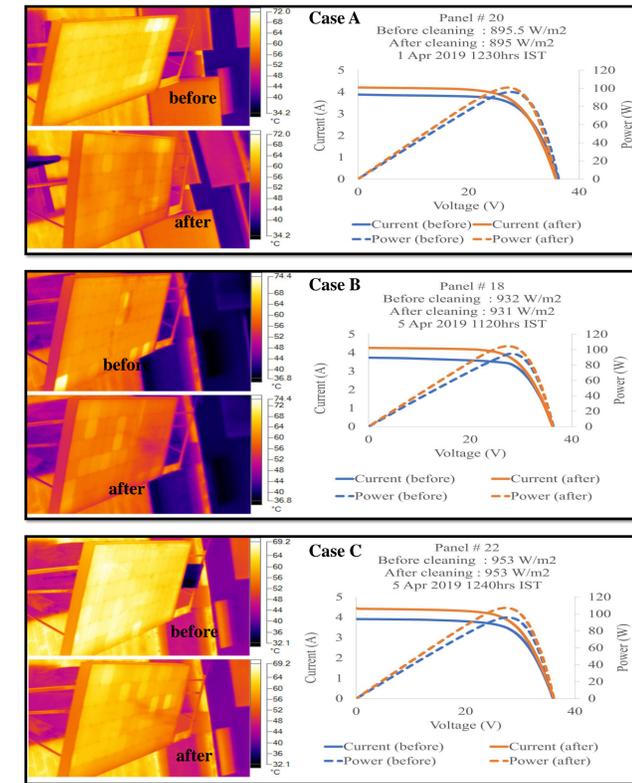
- The scatter plot of dust density and difference in efficiency is shown above (H) for three panels. Higher dust settlement at the edges of the panel was seen, possibly due to the influence of wind and rain/dew collection (pooling) along the frame edges over time.
- The common phenomenon observed in most of our panels were the absence of heated cells post cleaning. In the following picture (I-J), indicated by the dotted circles, the heated cells underlying soiling region disappear after cleaning. This phenomenon was observed in [2] as well. According to the [3], possible reasons for the hot cells are cell mismatch, cell internal defect and defective front contact. Our observation suggests the possibility of dust and soiling to also cause heated cells.

- In **Case A**, heated cells are significant, and they disappear after cleaning. In **case B** and **C**, the heated cells are noticeable after cleaning too. But, the differences in the three I-V curves of panels are similar and hence in our observations, presence of heated cells show no unique change in performance of panels. In [3], there was a noticeable power loss, while in [4], no performance decrease was observed. The current study observed 2-10 heated cells in panels with 72 cells, and found no significant on panel performance.
