## Introduction

- Current study is based on panels commissioned as part of a BIPV for 8 years, and currently stacked on site as spares. This study could reveal annual degradation in panels that are stacked on site, exposed to ambient conditions, but not in operation.
- These panels were also studied for the impact of soiling on operating cell-temperatures and other defects.
- Thirty-three 9-year-old monocrystalline Photovoltaic (PV) panels were inspected for degradations and simultaneous PV performance using thermal imager and I-V curve tracers respectively.
- Picture (A) shows the setup for degradation inspection and I-V curve measurement of PV panels. The setup is located at Centre for Sustainable Technologies, Indian Institute of Science campus, Bangalore.

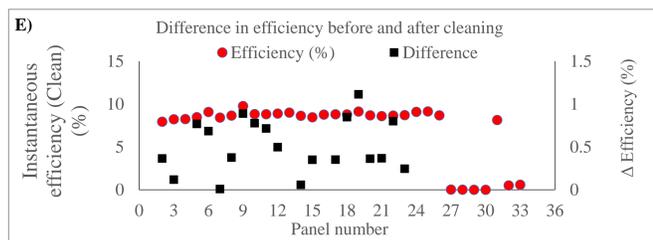
- I-V curves and simultaneous radiation measurement were made using AMPROBE solar-600 Solar Analyzer and AMPROBE Solar-4000 sensor respectively, before and after cleaning the panels. Following, efficiency calculations are shown below (E).

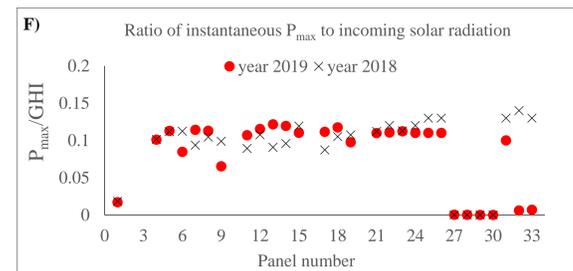
- The current year's performance was compared with the same of previous year [1]. Plot shown below (F) indicated a weak consistency in change in performance between the year 2018 and 2019.
